Case 250 : Narrative

Case Vehicle (A): 2000 Ford
Type: Ranger XL, 4 x 4, 4-door pickup
Driver: 16-year-old male
CDC: 11-FLEE-3

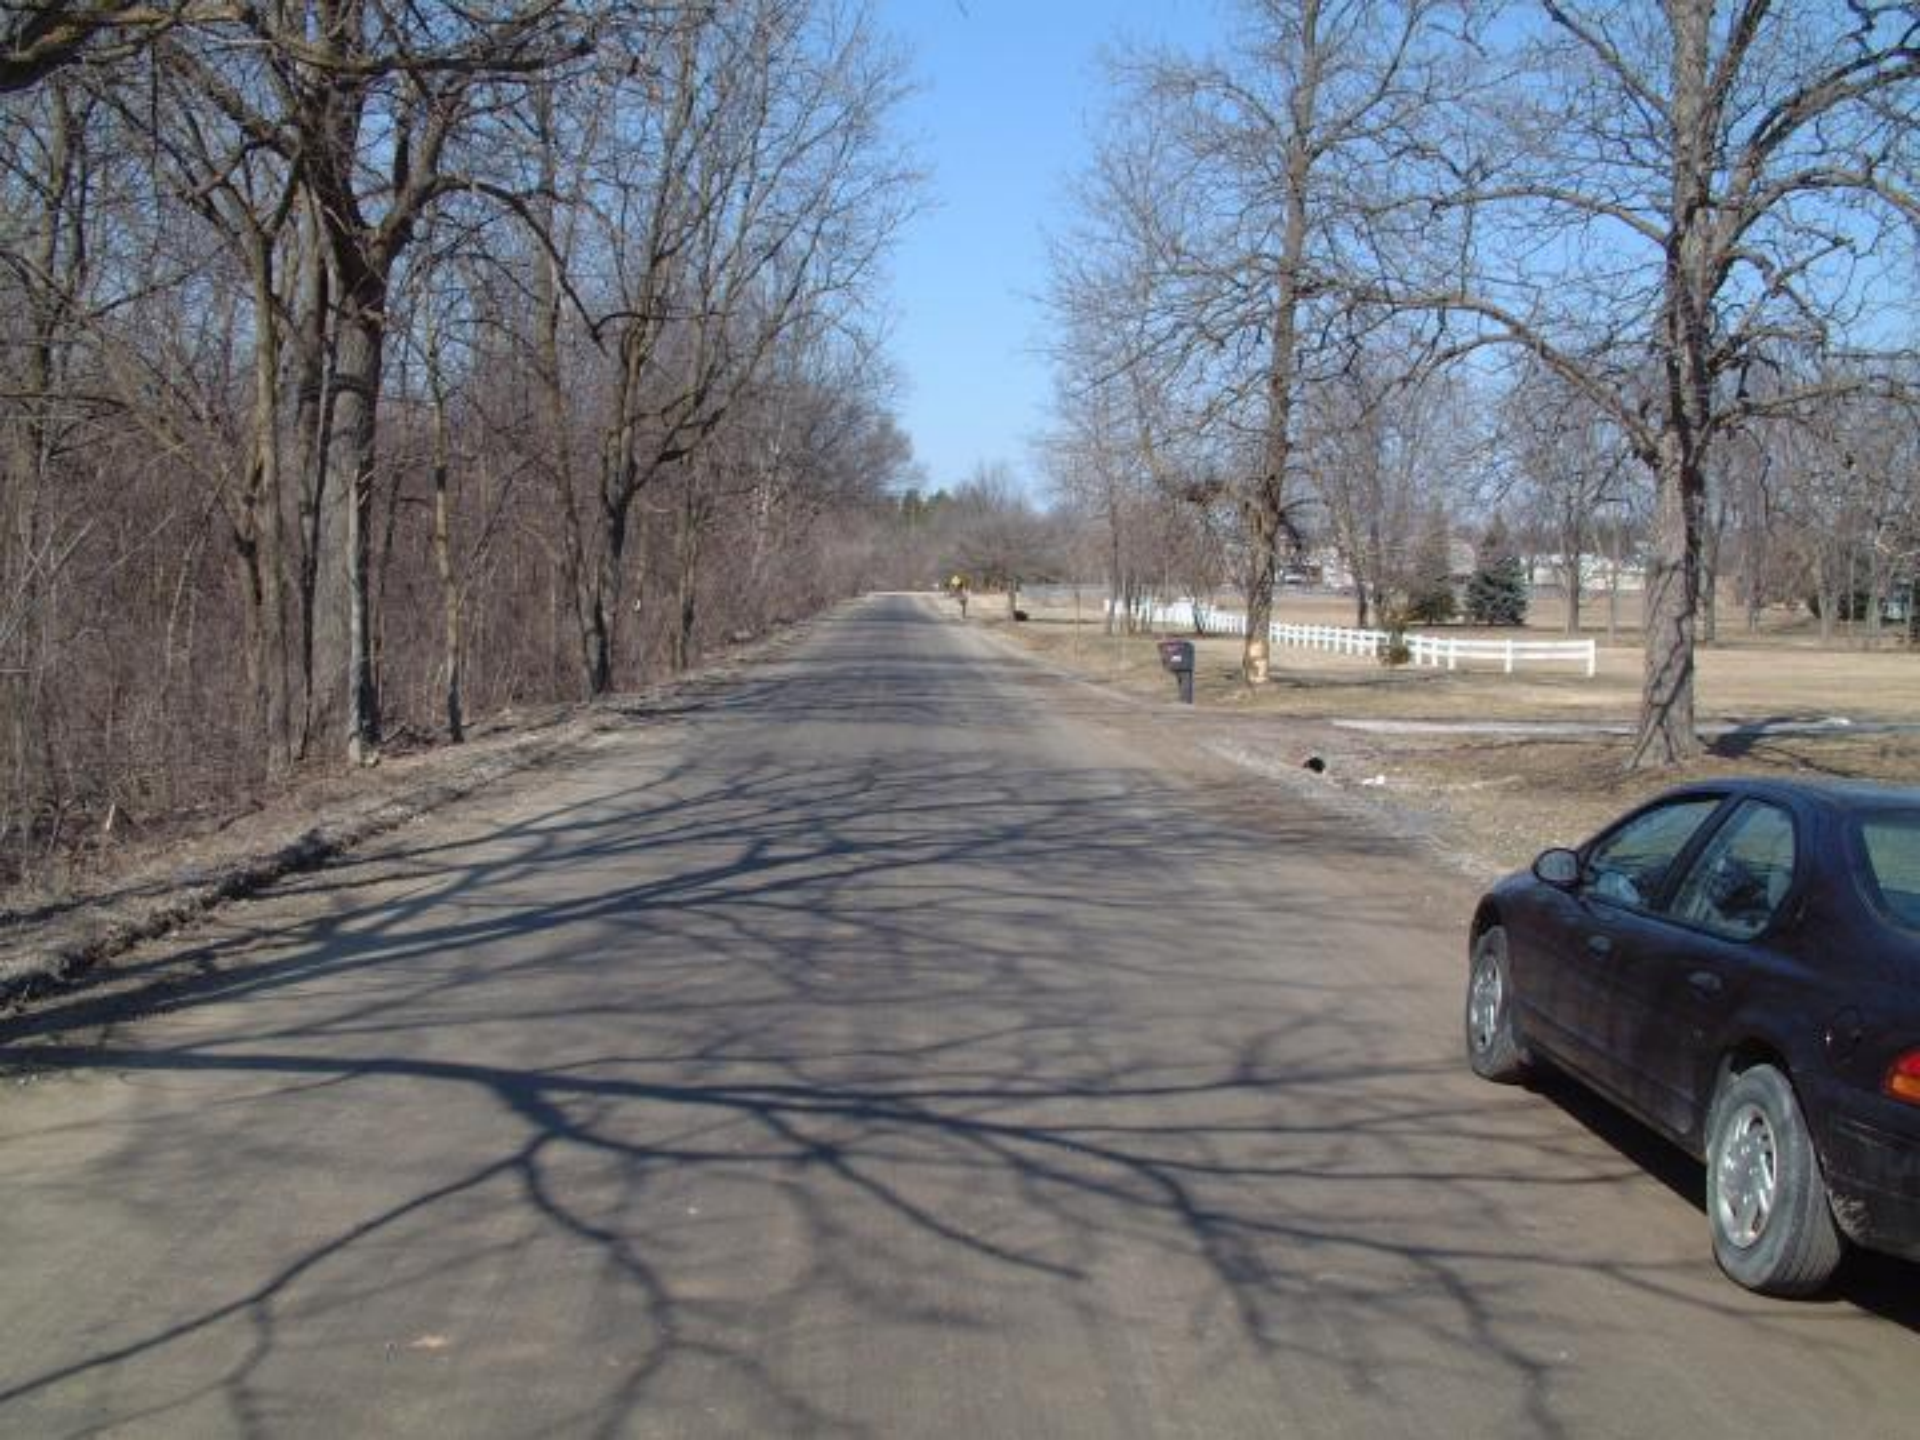
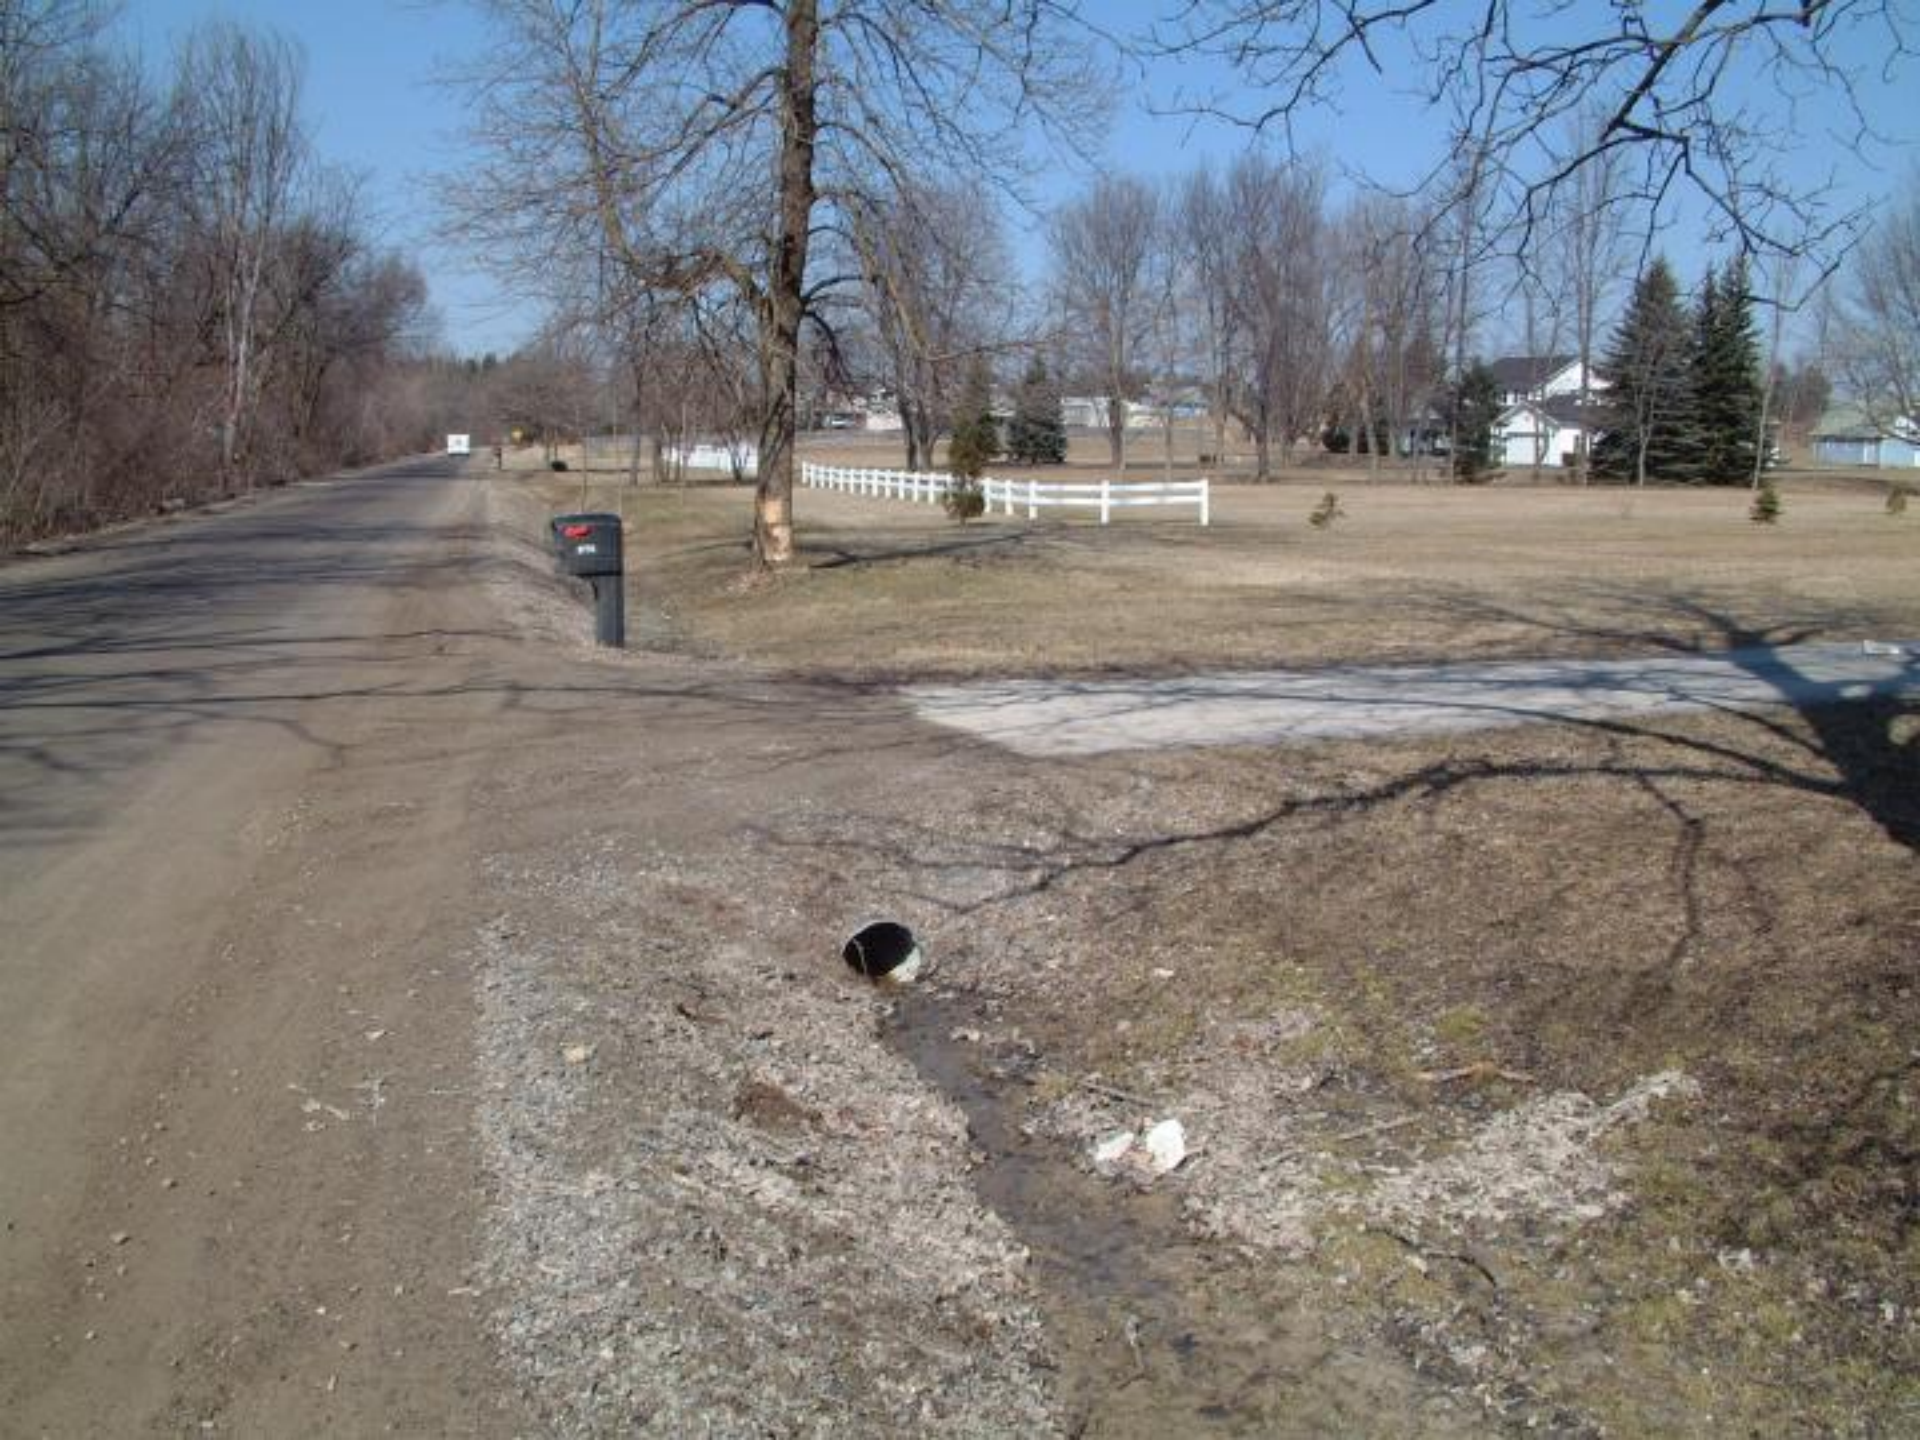
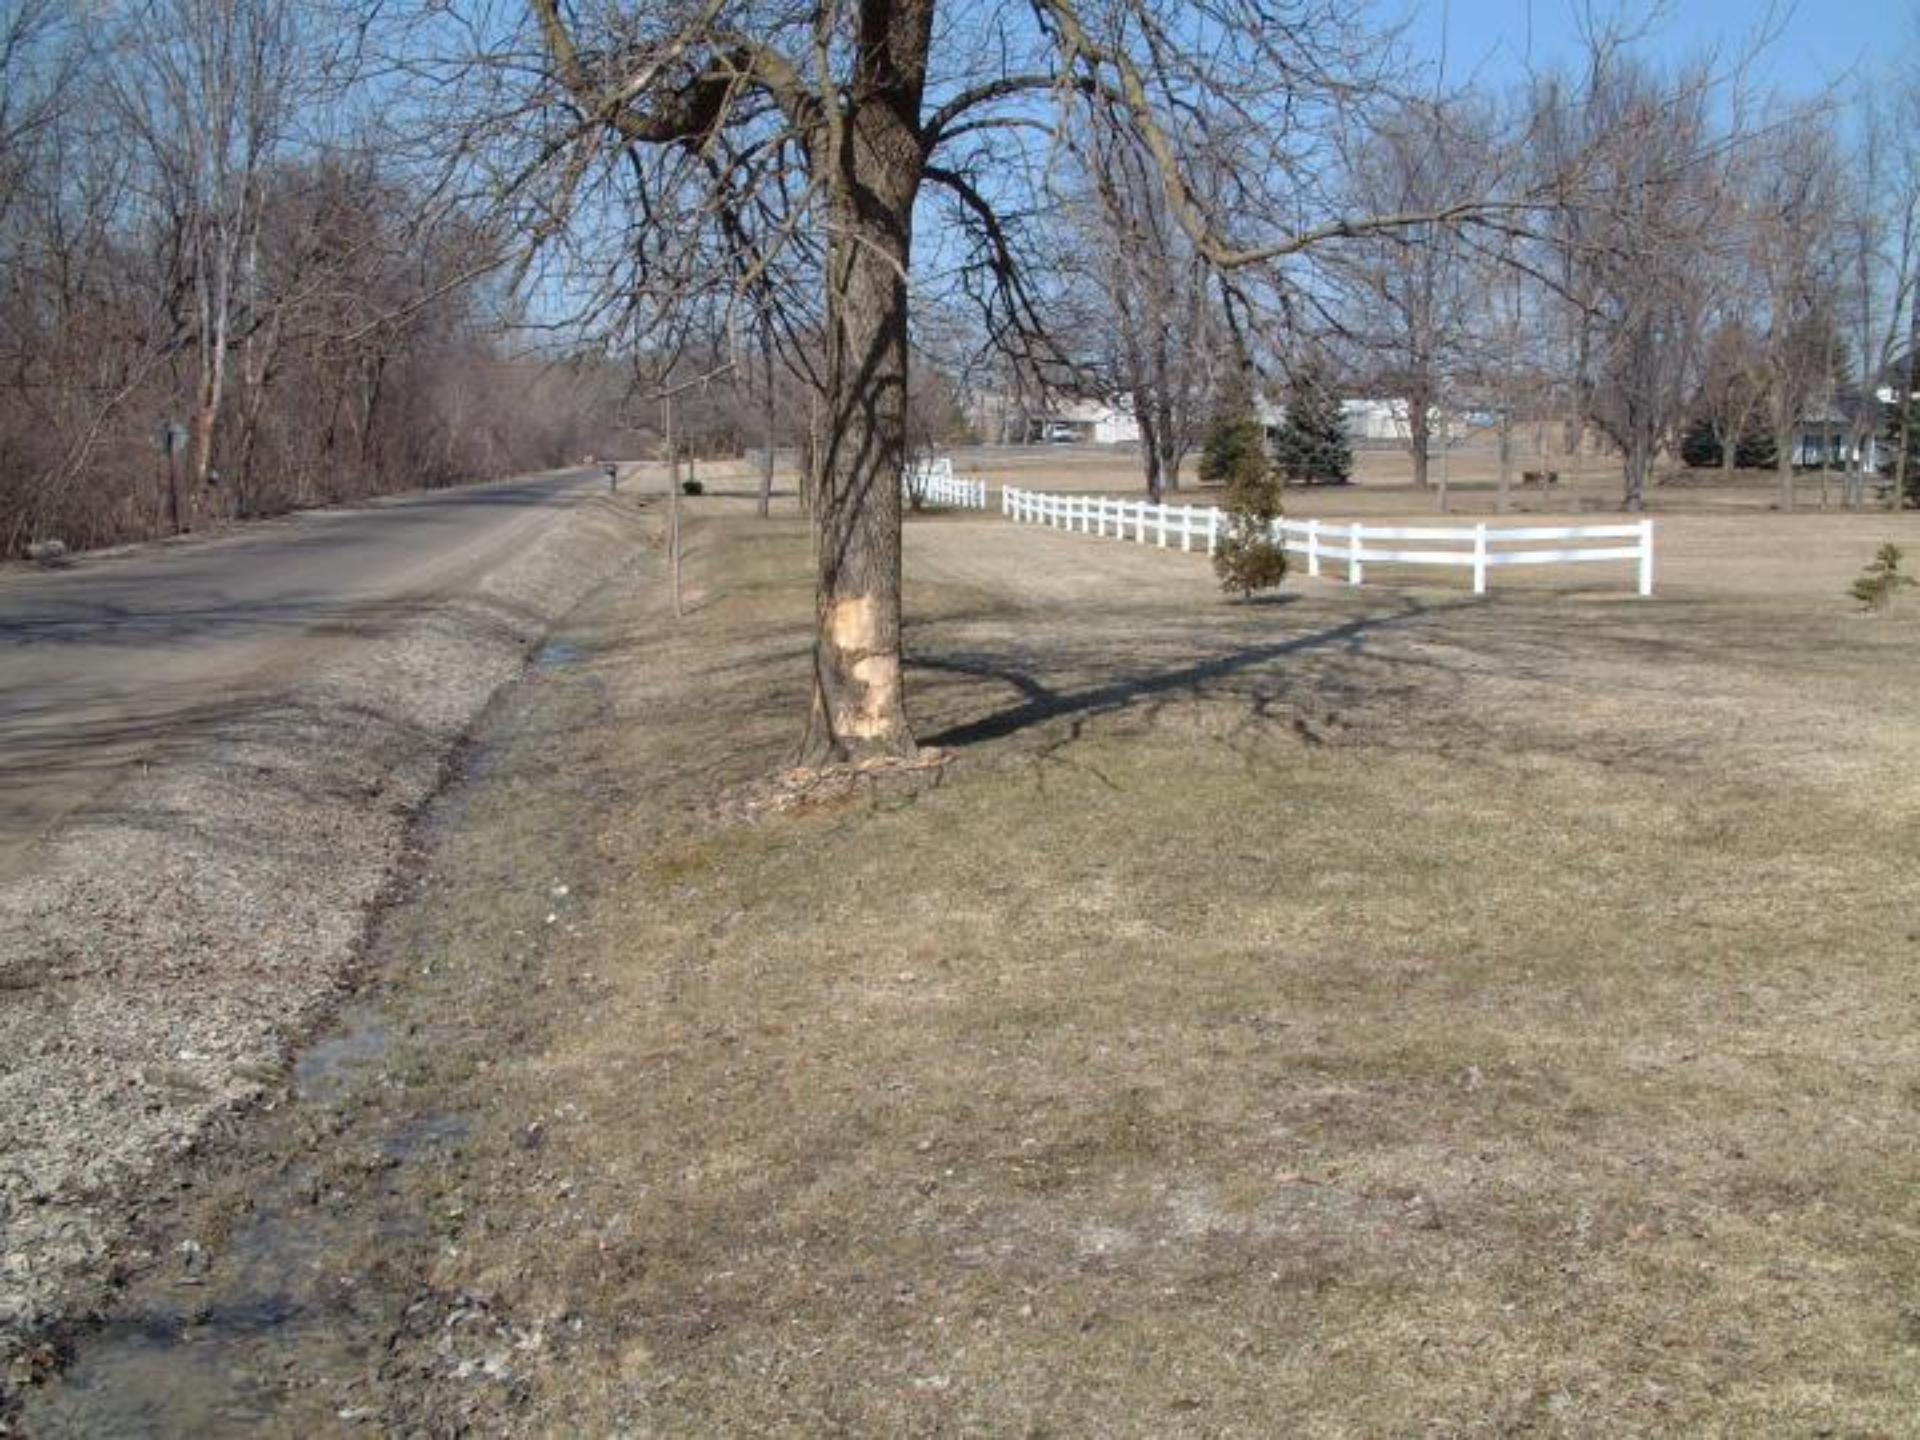
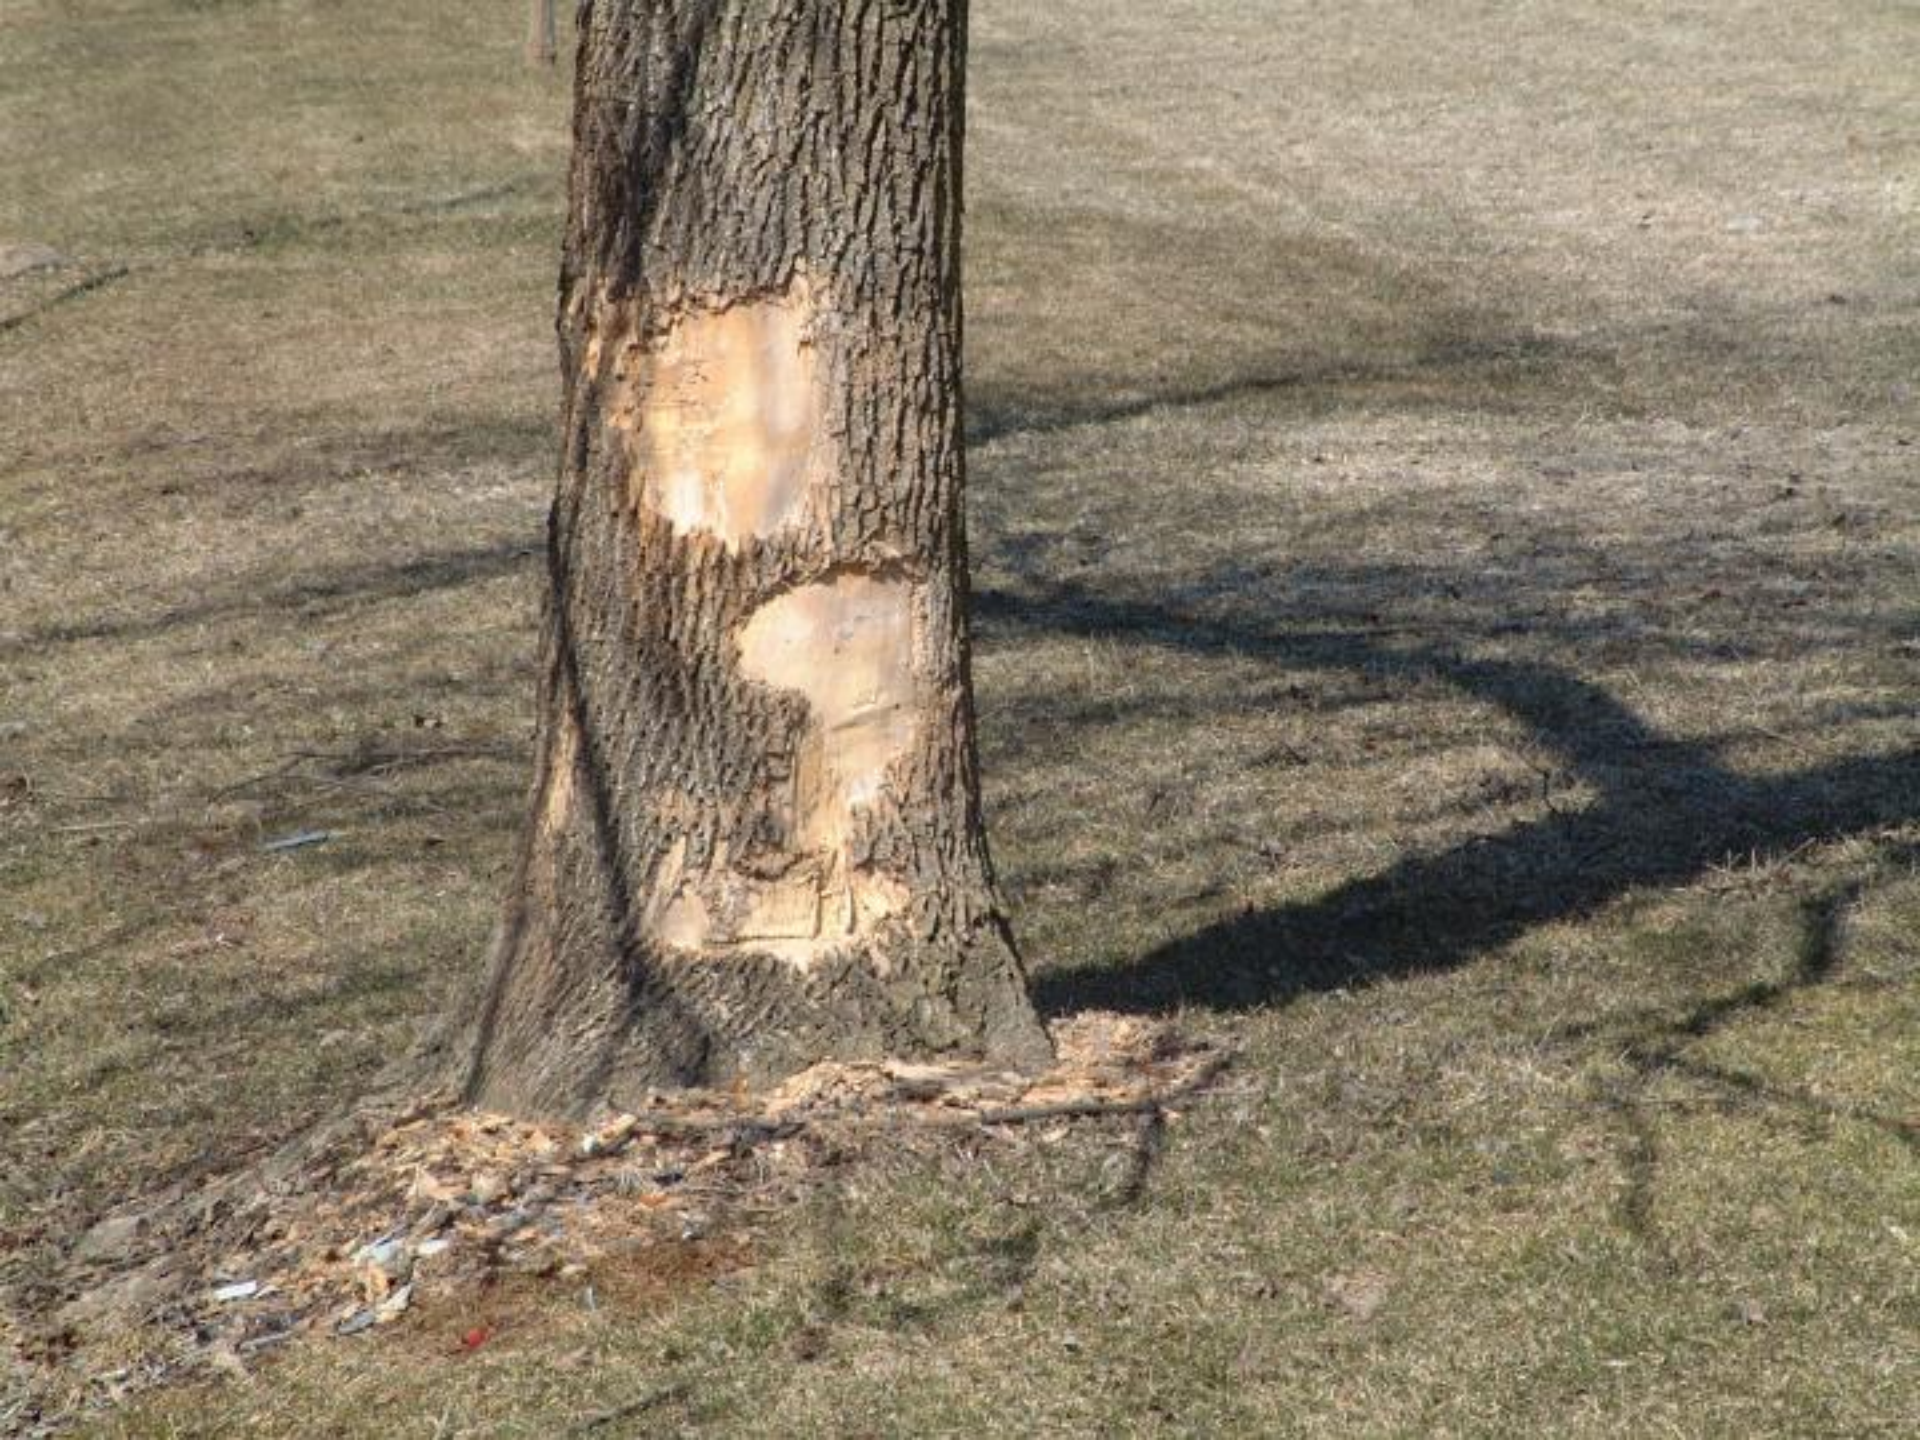
[6](#) Damage to case vehicle (A) was severe. [7](#) Direct damage began at the left bumper corner and extended 34 cm to the right, resulting in 27-percent vehicle overlap. The maximum crush was 53 cm to the left bumper corner.

Using the WinSMASH accident-reconstruction program and [8](#) [9](#) [10](#) [11](#) a crush profile measured at the front of case vehicle (A), the following impact severity was calculated:

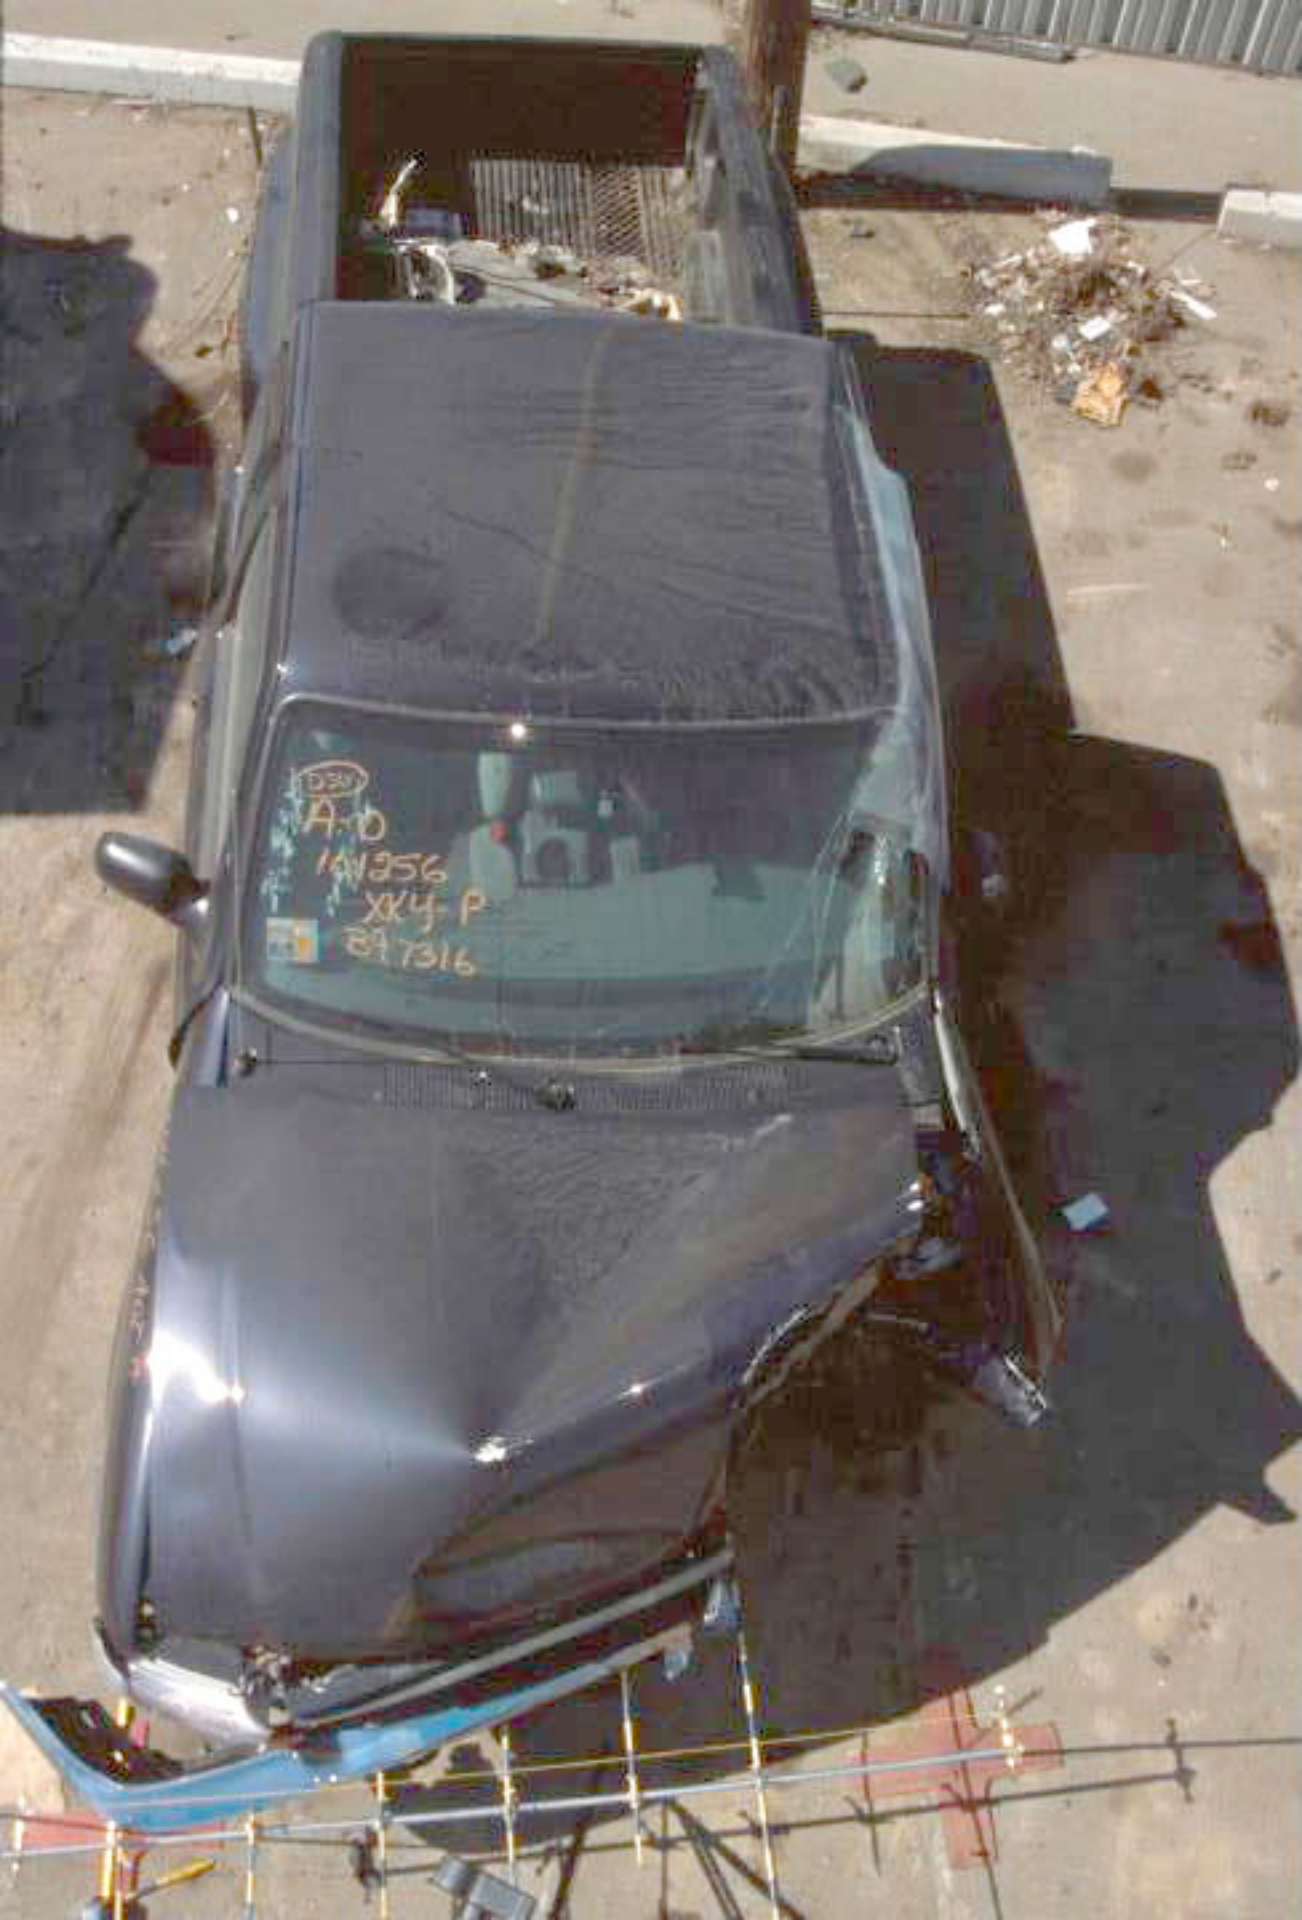
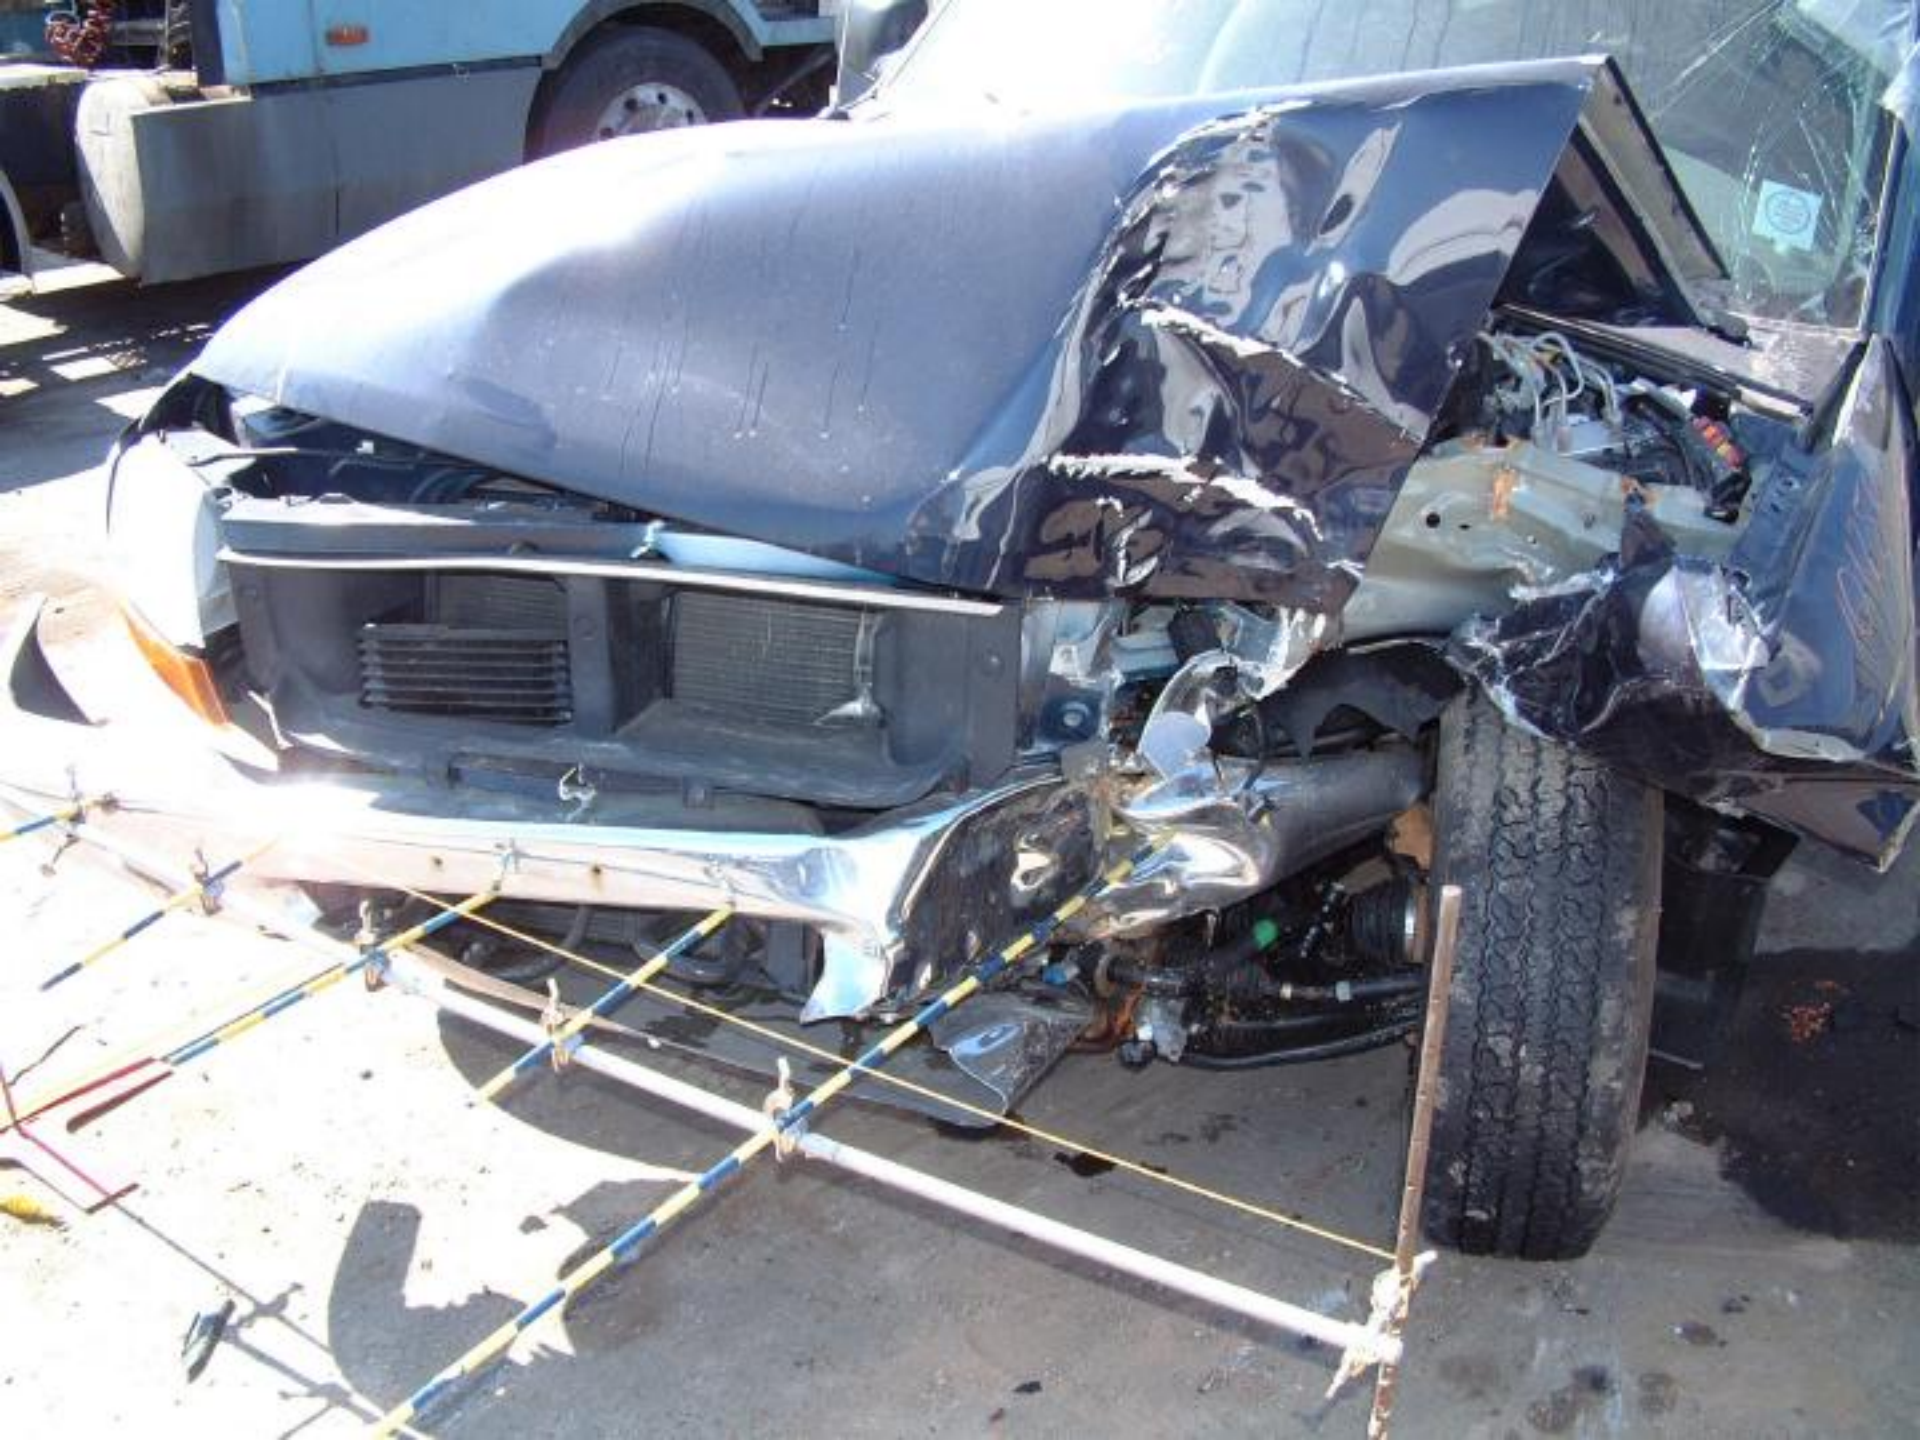
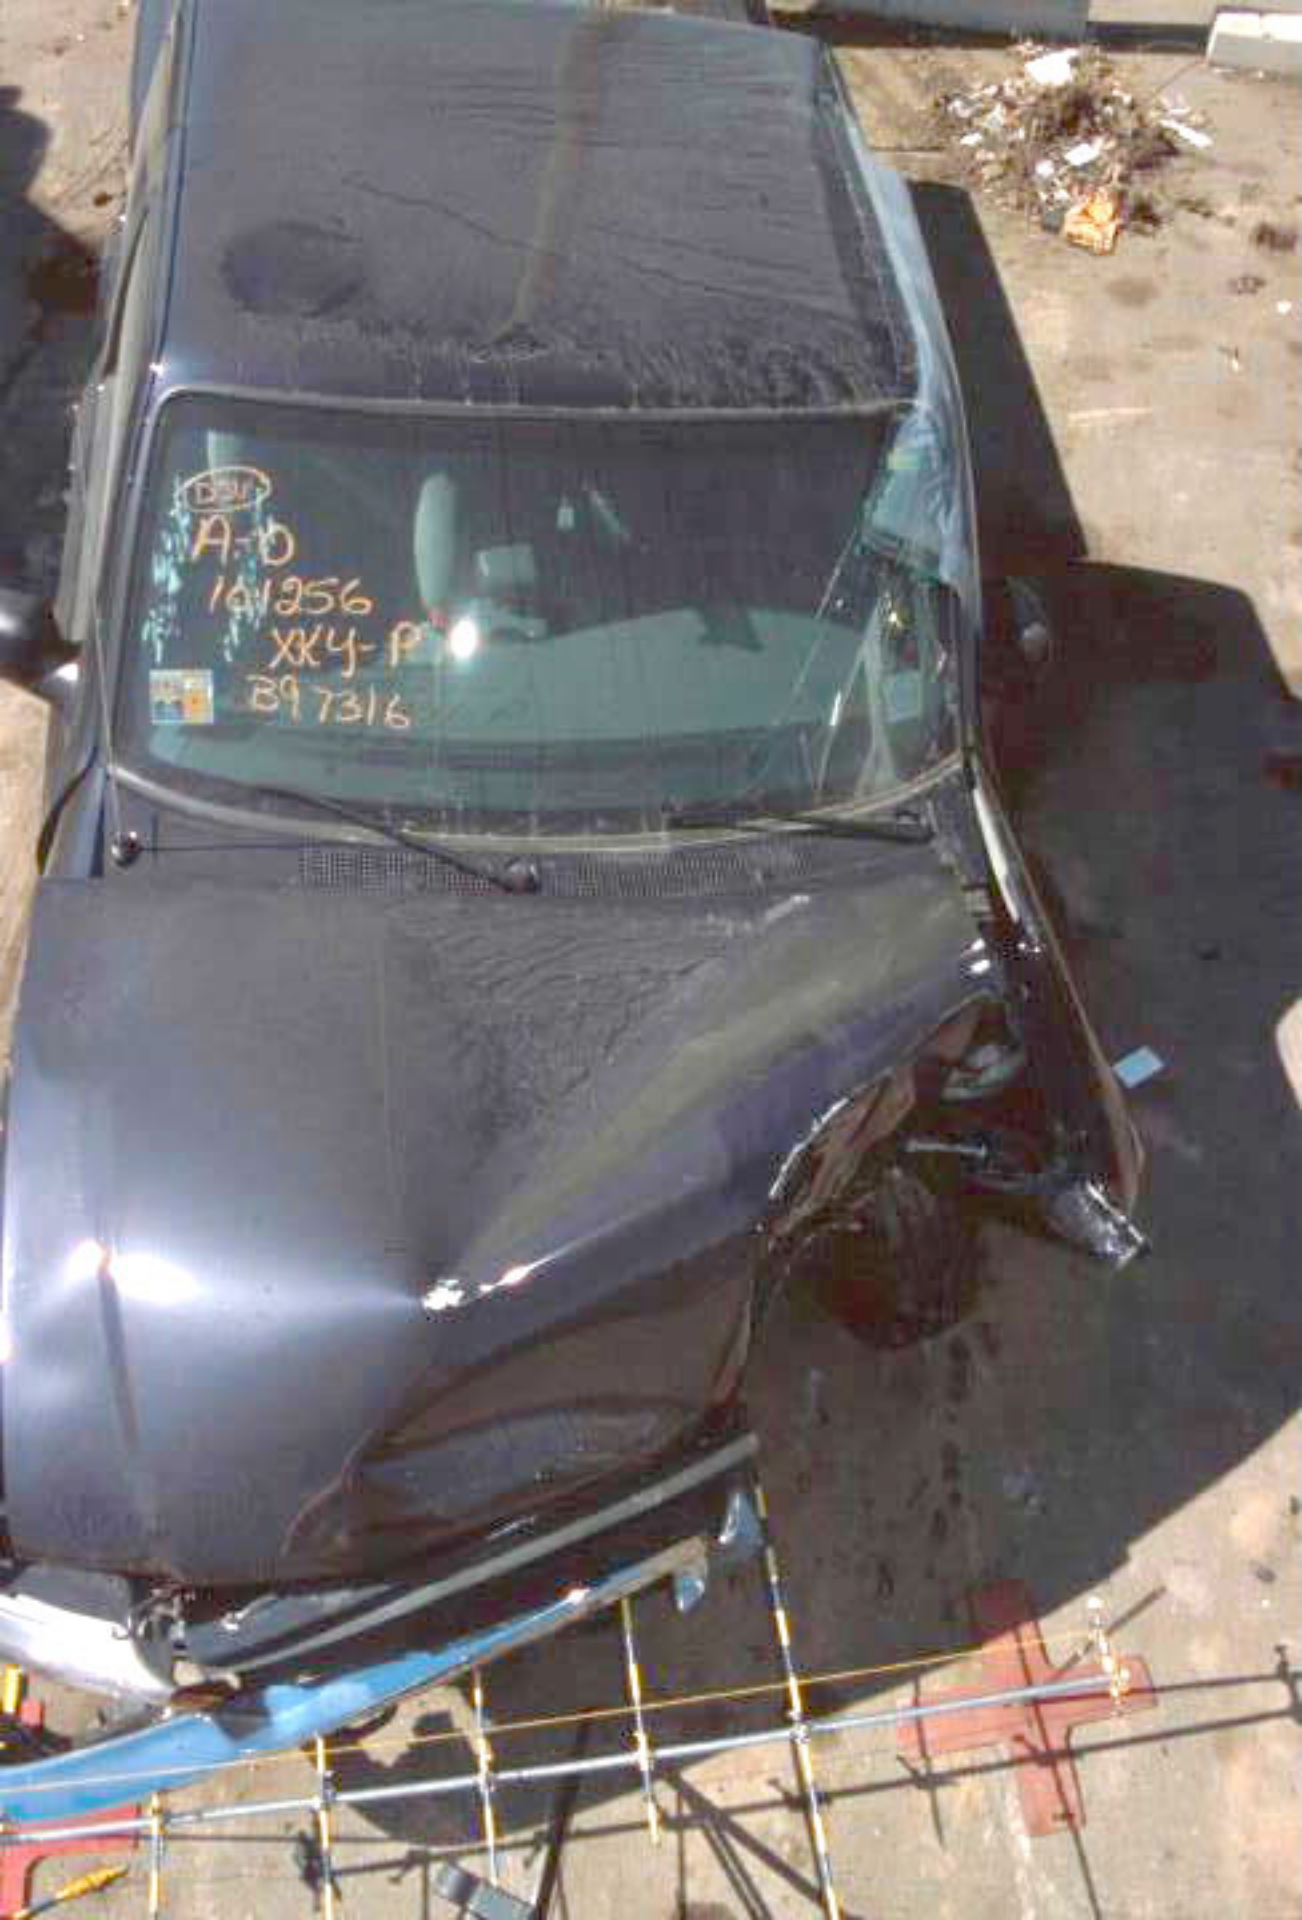
In the front, [12](#) the left portion of the bumper, the grille, the hood, and the engine compartment were crushed rearward. The left-front suspension was bent rearward. [13](#) The left portion of the engine compartment was severely crushed. [14](#) The left portion of the hood was folded in half. The hood latch was damaged and jammed closed. Both hood hinges were damaged, but not separated. [15](#) The rear edge of the hood was elevated, but it did not contact the windshield. [16](#) The left portion of the windshield was cracked due to body distortion.
